2005 Annual Operations Report for INTEC Operable Unit 3-13, Group 1, Tank Farm Interim Action

February 2006

Idaho Cleanup Project

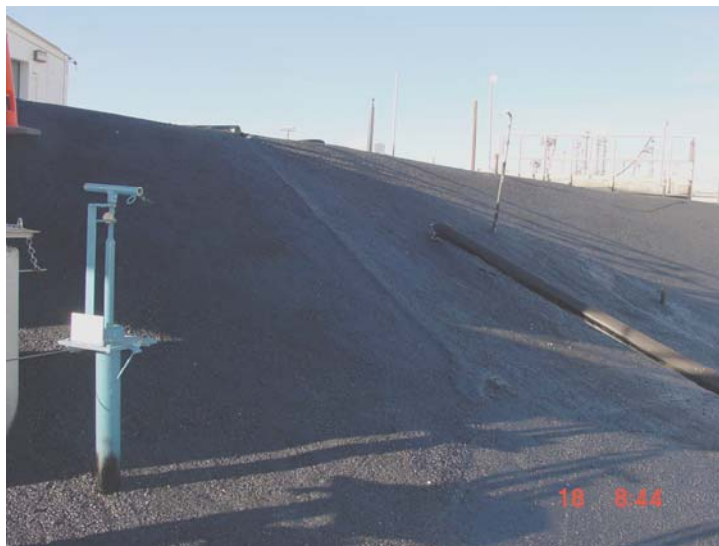
Figure B-4. Showing drain line over Site CPP-79 removed, depression filled in with concrete, and area sealed with seal coat.

3/29/05	Minor debris observed in Ditch TF2 (gravel, paper) and Ditch TF1 (plastic). Ditch FS1 and Culvert C15 contained cigarette butts.	Work Request 60000108 was written to have ditches and culvert cleaned of debris. Work completed by June 30, 2005.
9/13/05	Polyvinyl chloride (PVC) drainpipe from the top of the CPP-604 berm has separated from the asphalt and is allowing surface runoff to get under the surface-sealed area.	Lower part of drainpipe was removed and depression filled in with concrete. Areas around inlet/outlet of remaining drainpipe were sealed. Heat blankets were used to prevent freezing of concrete during curing process. Area seal-coated after concrete was cured. Repair method and materials approved by TFIA design engineer. Agencies were informed of repair plans during a WAG 3 conference call dated October 13, 2005, and Agencies approved of the use of concrete. Repairs were made within the 30-day time period between discovery and repair as required in the O&M plan (see Figures B-2, B-3, and B-4 in Appendix B).
